INDOOR AIR QUALITY REASSESSMENT

**Leicester Primary School
170 Paxton Street
Leicester, Massachusetts**

Prepared by:
Massachusetts Department of Public Health
Center for Environmental Health
Bureau of Environmental Health Assessment
Emergency Response/Indoor Air Quality Program
October 2004

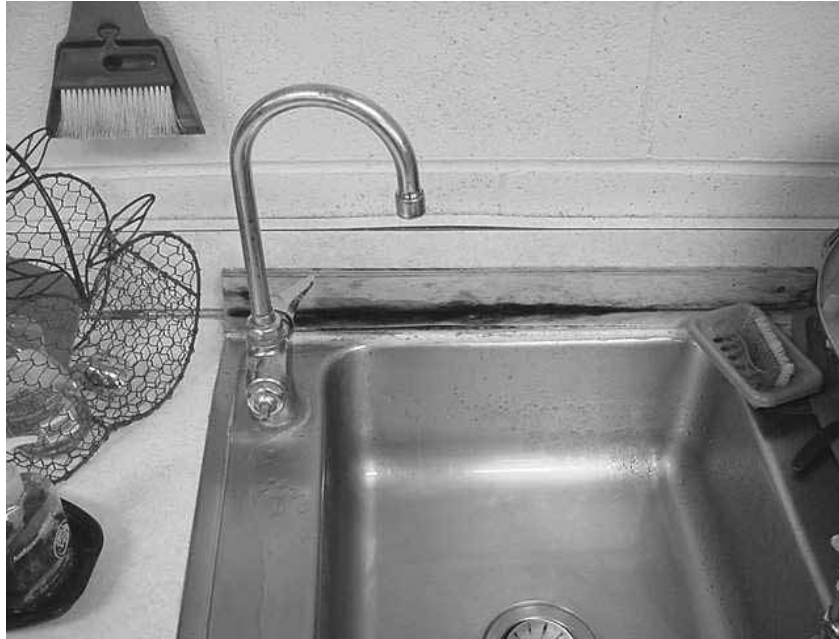
Picture 1

One classroom had a water-damaged splashguard (Picture 1). Water-damaged particleboard can provide a source of mold and mildew and should be replaced.

A Water-Damaged Splashguard

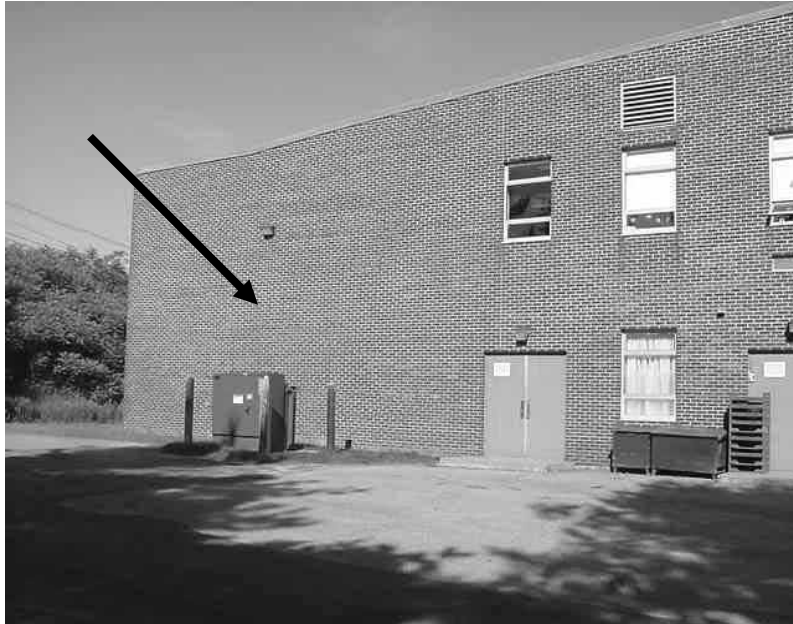
Picture 2

Room 101 West Wall

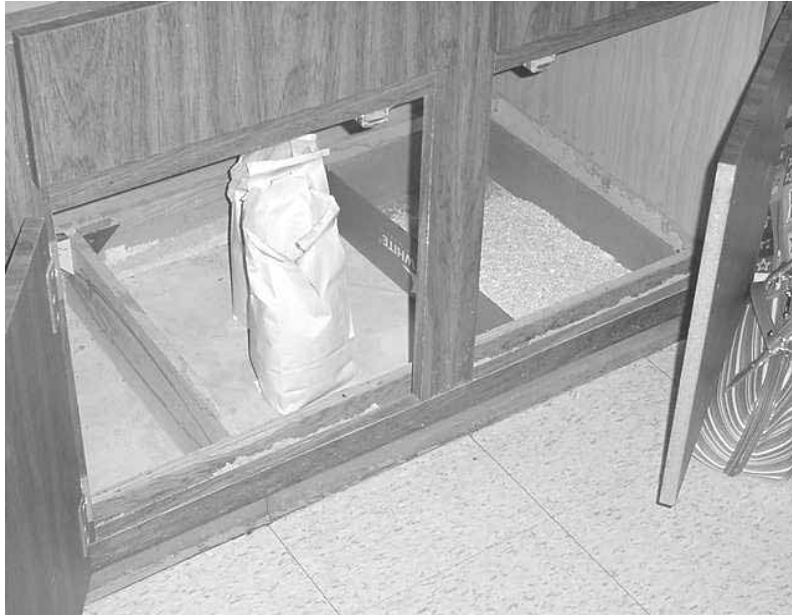
Picture 3

Mr. Feeney detected a chemical-like, musty odor upon entering this room that was traced to a sink cabinet that had experienced water damage. The cabinet (Picture 3) was composed of plywood/particle board. Plywood is made using an adhesive that consists of urea-formaldehyde resin (US EPA and US CPSC, 1995). Under conditions of increased temperature and humidity indoors, the urea-formaldehyde resin can breakdown, releasing formaldehyde vapor. Formaldehyde is a volatile organic compound (VOC) that can cause irritation to the eyes, nose and throat. As the formaldehyde vapor evaporates, the other component of the resin, urea, remains in the particleboard. Urea has a urine-like odor, particularly detectable if it is mixed with water vapor. Mr. Wicklund agreed to remove this cabinet during the summer vacation.

Cabinet with Odor, Note Bag and Box Filled with Treated Wood Shavings

1. Continue with plans to remove sink cabinet from room 101.
2. Seal the seam between the slab and interior wall in room 101 prevent air, odors and insect migration into the building.
3. Once the interior wall seal is repaired, have a mason repair cracks in the slab and insert screen/vent in weep holes that both prevent insect penetration and drain water.
4. Reduce the amount of items stored in classrooms to provide cleanable surfaces.
5. Store chemicals and cleaning products properly and out of the reach of students.
6. It is highly recommended that the principles of integrated pest management (IPM) be used to rid this building of pests. A copy of the IPM recommendations (MDFA, 1996) can be downloaded from the following website:

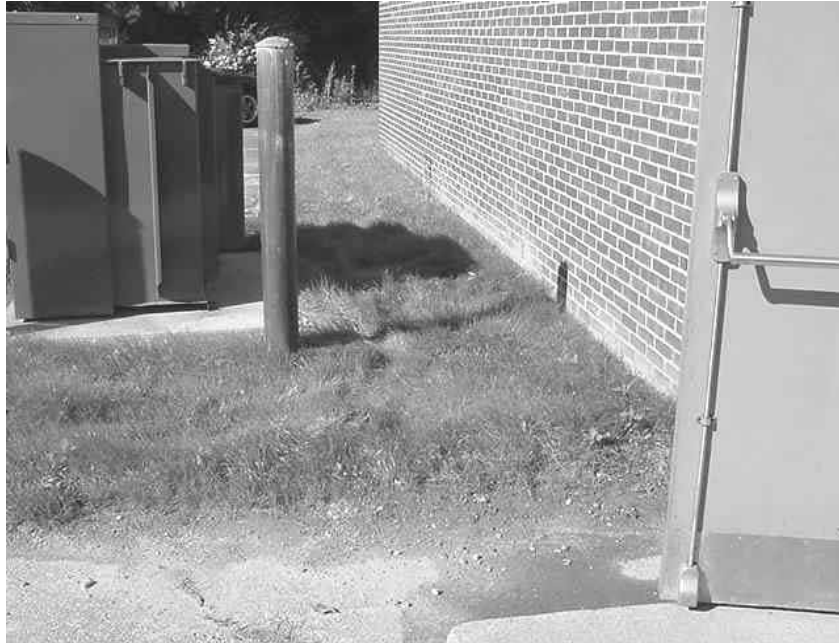
Picture 4

of odor and removal of contaminated soil, the exterior of the Room 101 west wall was examined (Picture 4). Of note was the presence of large a hole in the brickwork at the slab/exterior wall junction, just above the remediated area (as identified by Mr. Wicklund). These openings are called weep holes. Exterior wall systems should be designed to prevent moisture penetration into the building interior. An exterior wall system should consist of an exterior curtain wall. Behind the curtain wall is an air space that allows for water to drain downward and for the exterior cladding system to dry. At the base of the curtain wall should be weep holes that allow for water drainage. Opposite the exterior wall and across the air space is a continuous, water-resistant material adhered to the back up wall that forms the drainage plane.

Area of Transformer Oil Removal

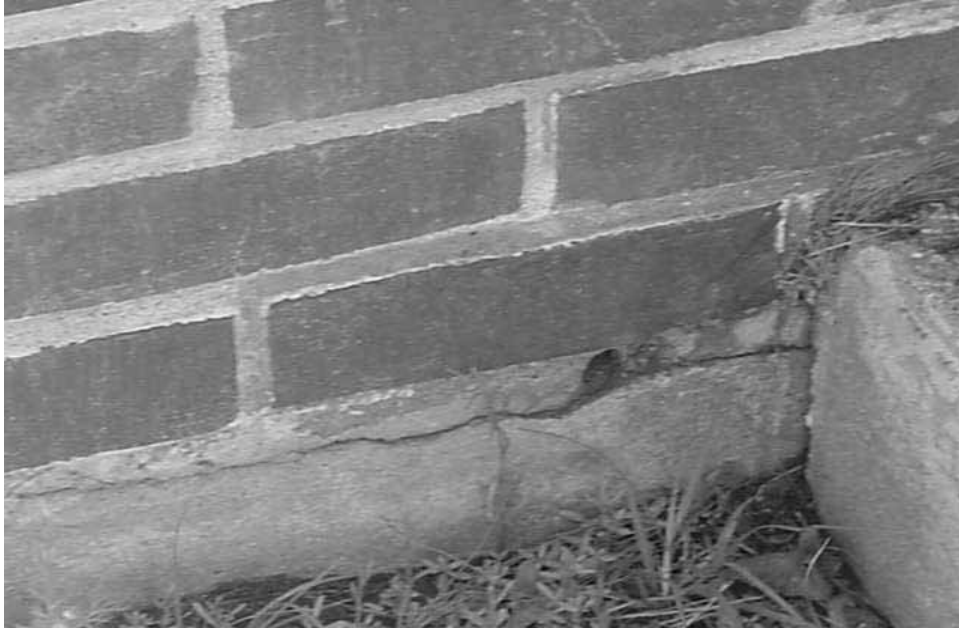
Picture 5

Weep Holes in West Wall of Room 101

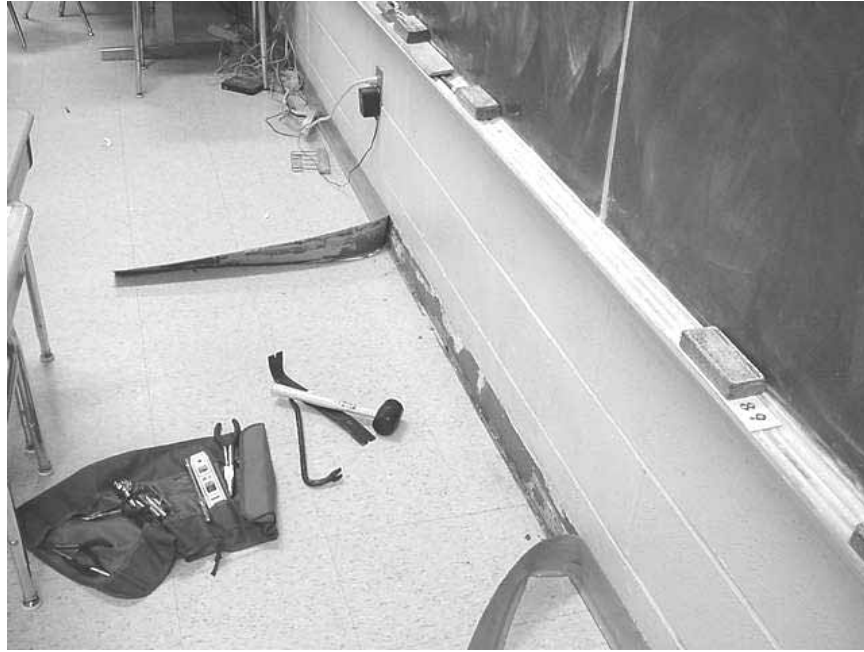
Picture 6

Plastic Coving Removed from the Base of the Room 101 West Wall

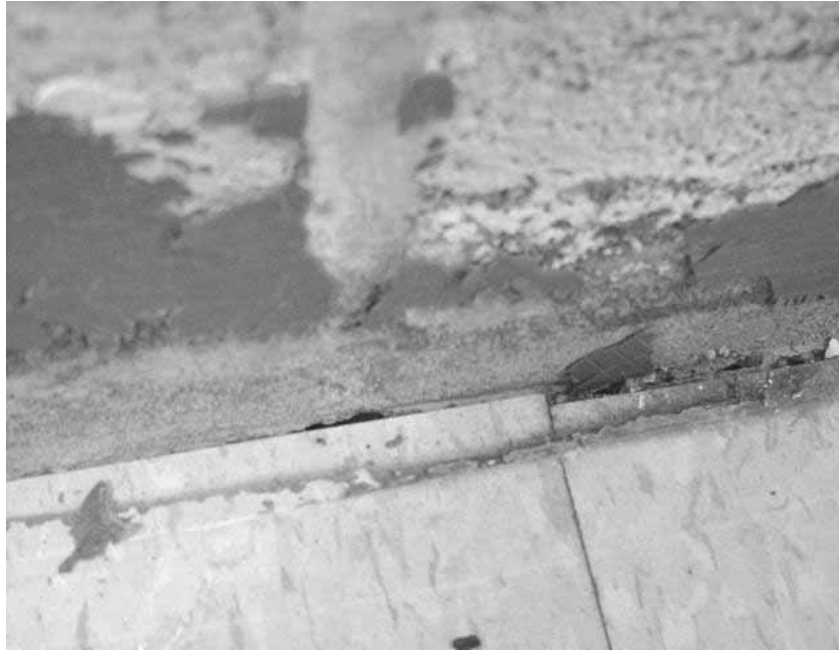
Picture 7

After making this determination, the interior of the Room 101 west wall was examined. The plastic coving along the wall was removed by Mr. Feeney. An opening in the seam between the wall and slab was identified (Pictures 6 and 7). In addition, present behind the coving were live insects. The presence of insects indicates that a breach exists in the wall drainage plane allowing insects to pass through the wall system. Thus, if insects can pass through this wall system, air and odors materials from outdoors can also gain entry into the Room 101 interior. Supporting this hypothesis is that the type of odor reported in this classroom abated once the remediation effort was completed.

Space in Seam of Floor/Wall in West Wall of Room 101
